PORTSMOUTH CIVIC CENTER

Final Submittal

**PACE Project #19050
April 17, 2019**

CONDITION ASSESSMENT

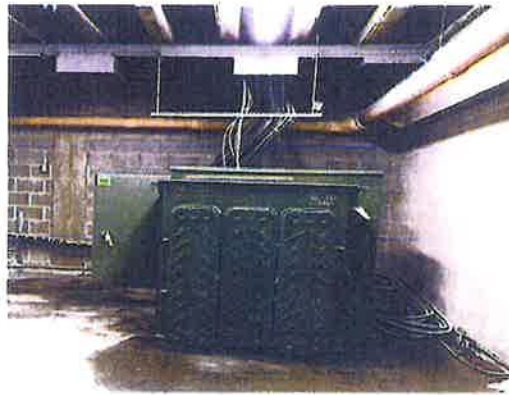
The electrical service for the Civic Center is provided from a Dominion Energy pad mounted transformer located in the basement. The area is separated from the other parking area by a chain link fence. The primary service enters the space in raceway and is run exposed through the space to the transformer. The doors to the primary section of the transformer are open to allow the primary feeder to enter the transformer. The secondary service from the transformer to the switchboard is run in feeder busway. The busway is run exposed from the transformer to the switchboard.

The switchboard and busway appear to be original to the building and is approximately 49 years old. The switchboard and busway are obsolete, and replacement parts would be very difficult to obtain. The switchboard is beyond the expected useful life of 30 years according to the "Building Owners and Managers Association" (BOMA).

Based on the condition and age of the switchboard, replacement is recommended.

In addition, we recommend that the service and transformer be relocated to a higher elevation to eliminate the potential for flooding.

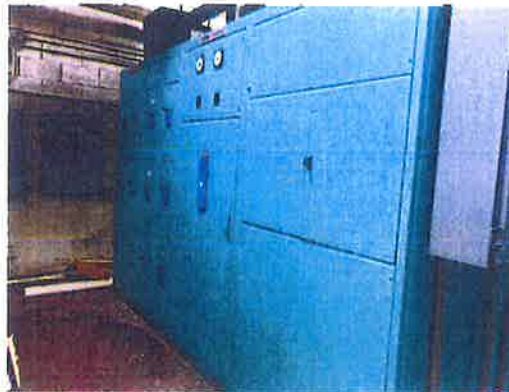
The electric service to the facility is rated 2500-amps, 480/277 volts, 3-phase, 4-wire. It is delivered via the Dominion Energy pad mounted transformer and busway to the incoming / metering compartment of the main switchboard. The existing switchboard is manufactured by General Electric A/V Line switchboard.

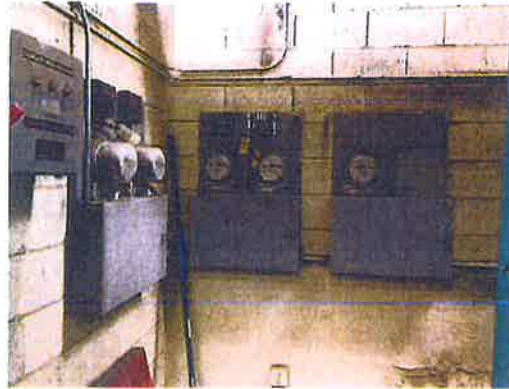
The electrical service is metered with five utility meters external to the switchboard.

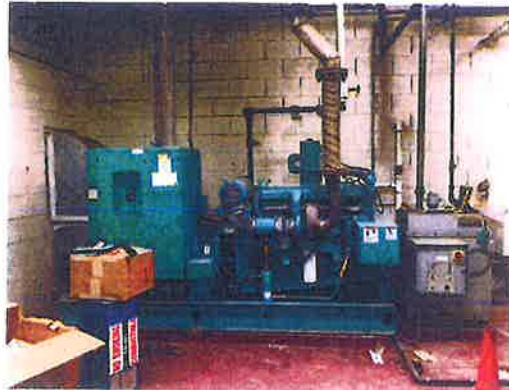
The first generator is a 230 kW at 0.8 power factor, 287.5 kVA, stand-by rated, 480/277 volts, 3-phase, 4-wire, diesel generator and is located in the basement in the mechanical /electrical room. The generator is a Cummins 230DFAB. It is water cooled via city water, which is discharged to a floor drain.

Both generators appear to be in good condition and are exercised on a weekly basis. They were installed around 1998 and should be approximately 21 years old. The expected life of the diesel generator is 20 years, and the expected life of the automatic transfer switch is 25 years according to the "Building Owners and Managers Association" (BOMA).

The diesel generators are just beyond their expected life; however, they have been exercised on a weekly basis and appear to be in good condition for their age.

In addition, we recommend that the generators and automatic transfer switches be relocated to a higher elevation to eliminate the potential for flooding.

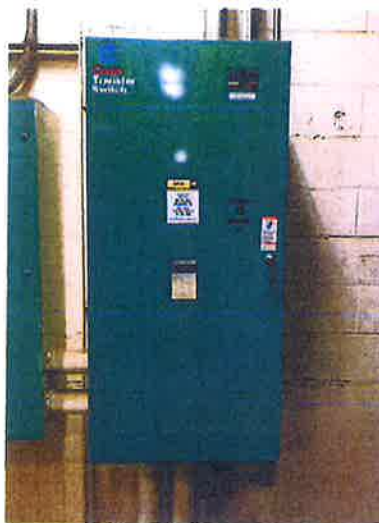
This generator feeds a 600-amps, 3-pole, 4-wire automatic transfer switch (Onan OT 600).

We recommend that the automatic transfer switches be replaced with 4-pole automatic transfer switches, and that the withstand and close on rating be coordinated with the available fault current.

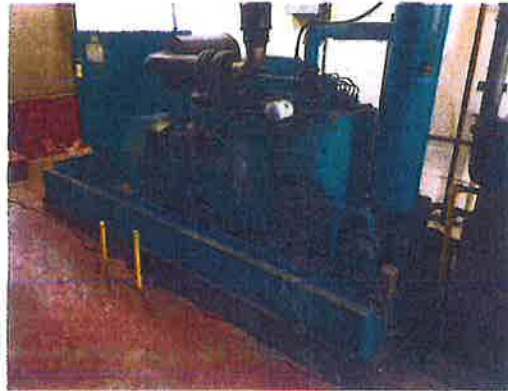
The second generator is a 150 kW at 0.8 power factor, 187.5 kVA, 480/277 volts, 3-phase, 4-wire, stand-by rated, diesel generator and is located in the basement in a separate generator room. The generator is a Cummins 150DGFA. It is water cooled via city water, which is discharged to a floor drain.

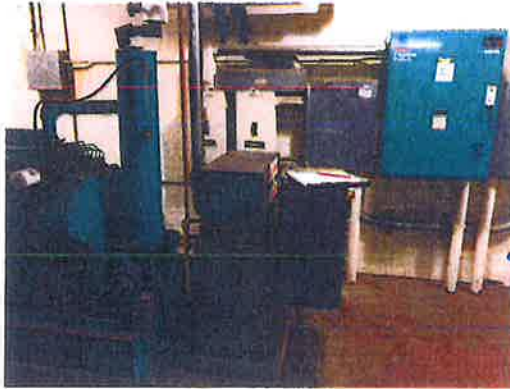
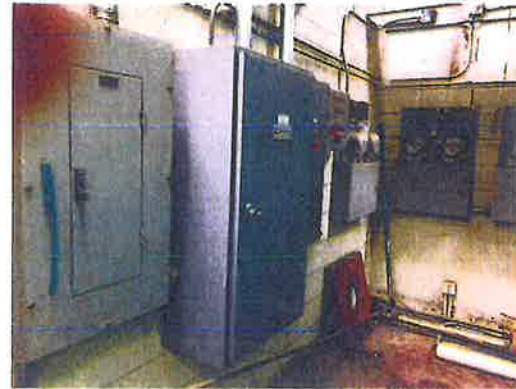
This generator feeds two 150-amps, 3-pole, 4-wire, automatic transfer switch. One automatic transfer switch is an Onan OT 150, and the other automatic transfer switch is a Zenith ZTS series.

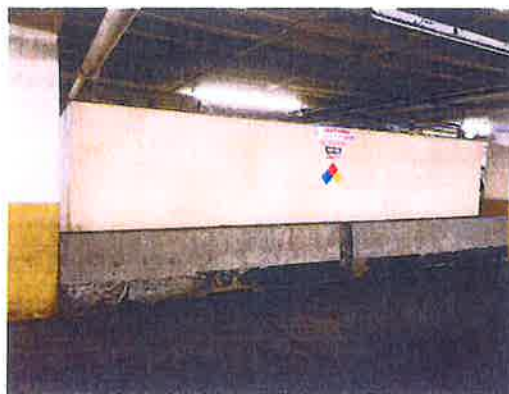
The diesel fuel is provided from an above ground, fire-rated fuel tank located in the parking garage in the basement.

The fuel system to the day tank does not have a return line and return pump to keep the day tank from overflowing in the event that the supply pump did not shut off when called for as recommended by NFPA 31.

We also recommend that the day tanks be replaced with a duplex pump arrangement so that it has a supply pump and a return pump as required by the NFPA 31.

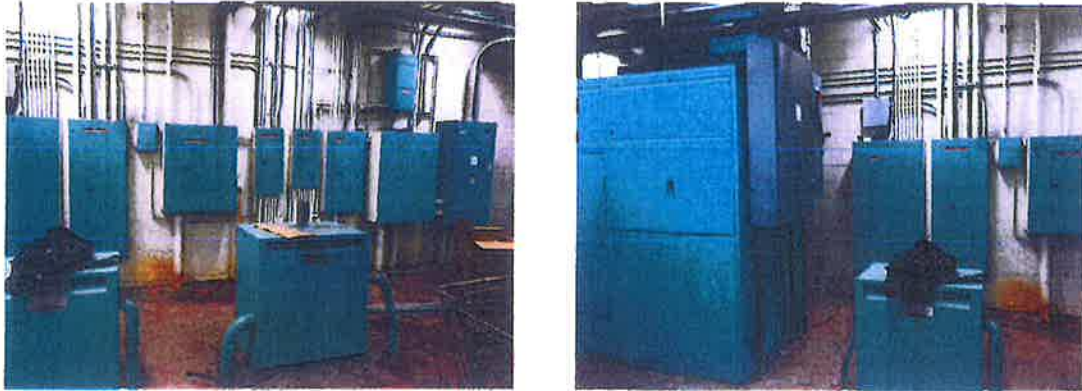
The electrical distribution equipment includes the panelboards, motor control center, and dry type transformers. These items are generally original equipment.

The panelboards, motor control center and dry type transformers appear to be original to the building and are approximately 49 years old. The panelboards and motor control center are obsolete, and replacement parts would be very difficult to obtain. These items are beyond the expected useful life of 30 years according to the "Building Owners and Managers Association" (BOMA).

Based on the condition and age of the panelboards, motor control center and transformers replacement is recommended.

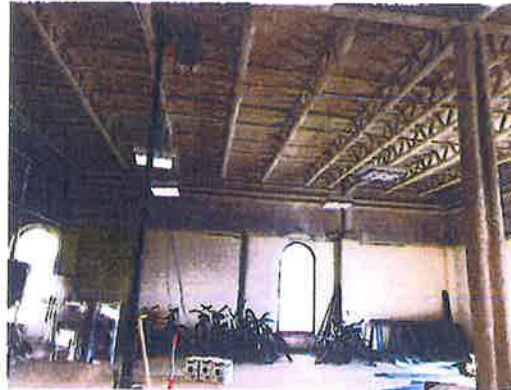
The branch circuits and feeders in this area of the facility appeared to be copper in metal raceway and original to the building.

Type "MC" cable appeared to be used for minor circuit revisions in these spaces.

Based on the existing drawing and electrical practice at the time of construction, we expect that the branch circuits included multi-circuit homeruns with a common neutral and no branch circuit equipment grounding conductor. With the new electronic ballast for the lighting, third harmonics created on the common neutrals could result in the neutral conductors being overloaded. If equipment grounding conductors are not included in the branch circuits, the loss of grounds could be expected due to the deterioration of the metal raceway in this area of the building.

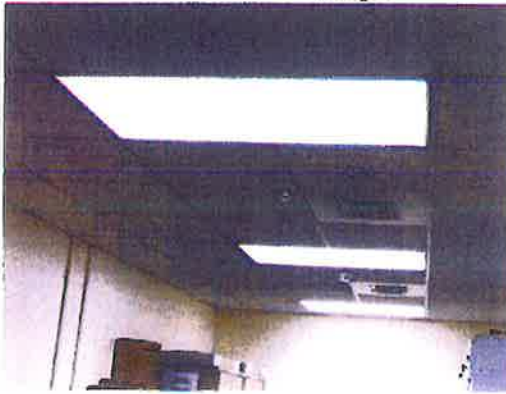
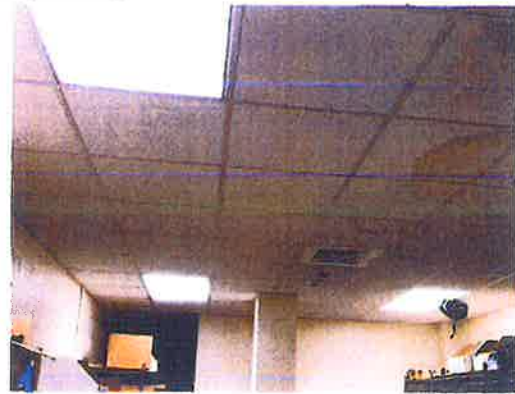
Lighting in the first floor office and administrative spaces generally consisted of recessed troffers with T-8 fluorescent lamps and electronic ballasts.

The lighting on the first floor appeared to be in fair condition with some maintenance required and dated lighting controls.

Most of the lighting has been upgraded to fluorescent fixtures with T8 lamps and electronic ballasts. These fixtures are aged and should be upgraded to LED to meet current energy use standards.

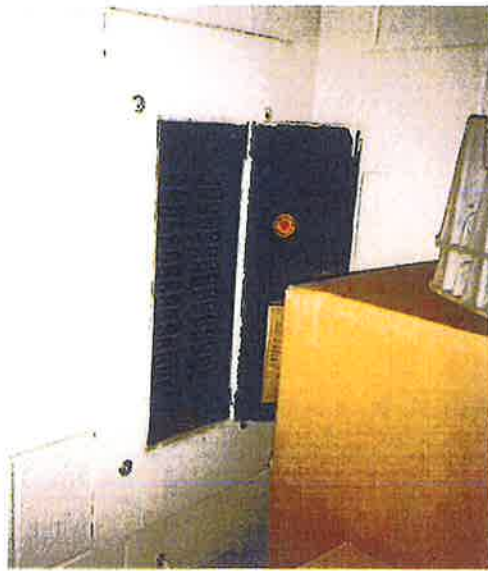
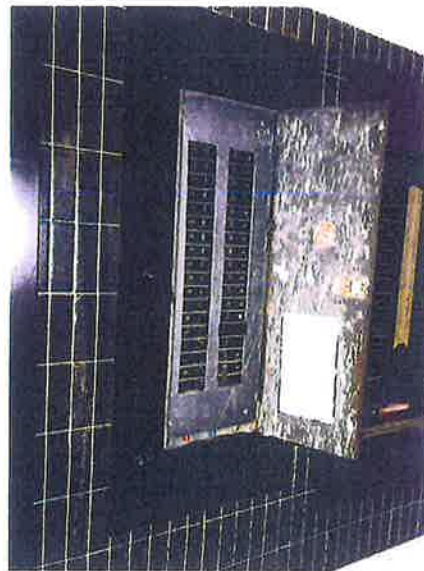
The electrical distribution equipment includes the panelboards and dry type transformers. These items are generally original equipment.

The panelboards, and dry type transformers appears to be original to the building and are approximately 49 years old. The panelboards are obsolete and replacement parts would be very difficult to obtain. These items are beyond the expected useful life of 30 years according to the "Building Owners and Managers Association (BOMA).

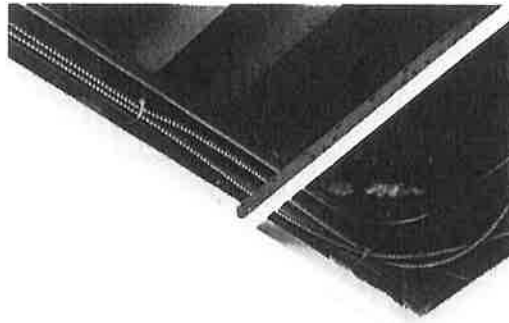
The branch circuits and feeders in this area of the facility appeared to be copper in metal raceway and were original.

Type "MC" cable appeared to be used for minor circuit revisions in these spaces.

Based on the existing drawing and electrical practice at the time of construction, we expect that the branch circuits included multi-circuit homeruns with a common neutral and no branch circuit equipment grounding conductor. With the new electronic ballast for the lighting and electronic power supply, third harmonics created on the common neutrals could result in the neutral conductors being overloaded. If equipment grounding conductors are not included in the branch circuits the loss of grounds could be expected due to the deterioration of the metal raceway in this area of the building.

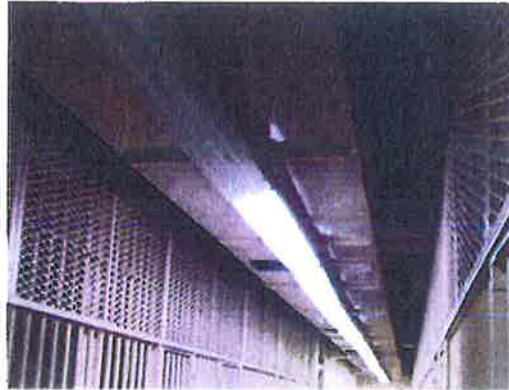
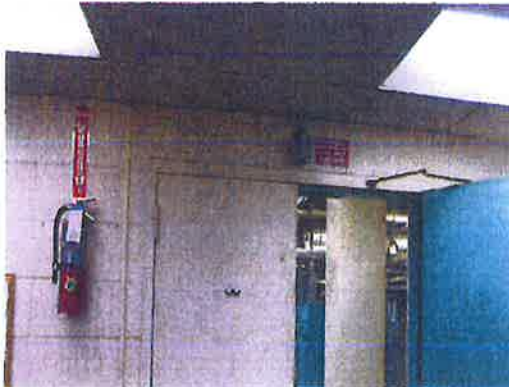
Lighting in the Jail Corridors generally consisted of 1x4, vapor-proof with T-8 fluorescent lamps and electronic ballasts.

The lighting in area with a finished SAP ceiling consisted of 2x4 recessed troffer.

The lighting appeared to be in fair condition.
